New York State Department of Transportation

PIA Red Flag NB23U4W017

BIN: 1065318

Location: Span 230, Girder G19 at Pier 229.

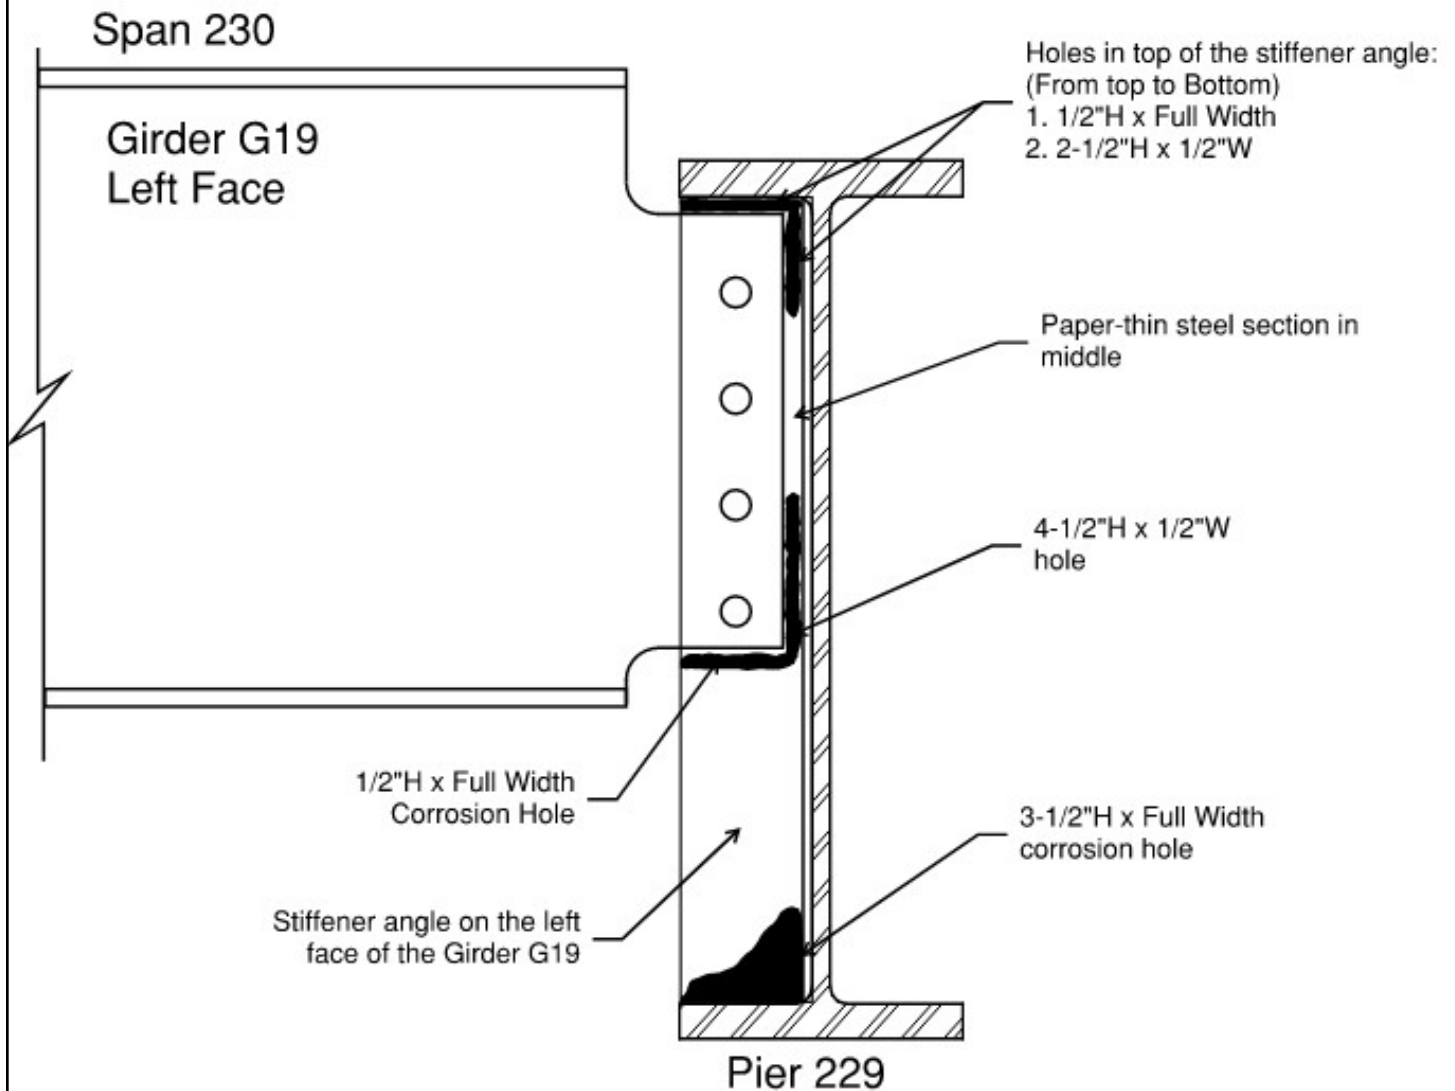
Photo Number: 2

1. The connecting leg of the stiffener angle has a 1/2"H x full width hole in the upper side of the connecting leg, above the girder web.

2. The portion of the connecting leg near the heel of the angle, parallel to the girder web end vertical edge, has two holes (i) 2-1/2"H x 1/2"W adjacent to the top corner of the girder web end, and (ii) 4-1/2"H x 1/2"W hole adjacent to the bottom corner of the girder web end. The portion between these two holes exhibits paper-thin steel surface.

3. The connecting leg below the girder web has a 1/2"H x full width hole.

4. There is a large hole (approx. 3-1/2"H x full width) at the base of the connecting leg, above bottom flange of the pier cap of Pier 229, on the Span 230 side. (See Sketch Photo No.2 and Photo Nos. 7 and 8).

SKETCH FOR PIA RED FLAG # NB23U4W017
SPAN 230, GIRDER G19 AT PIER 229
(LOOKING RIGHT)
N.T.S

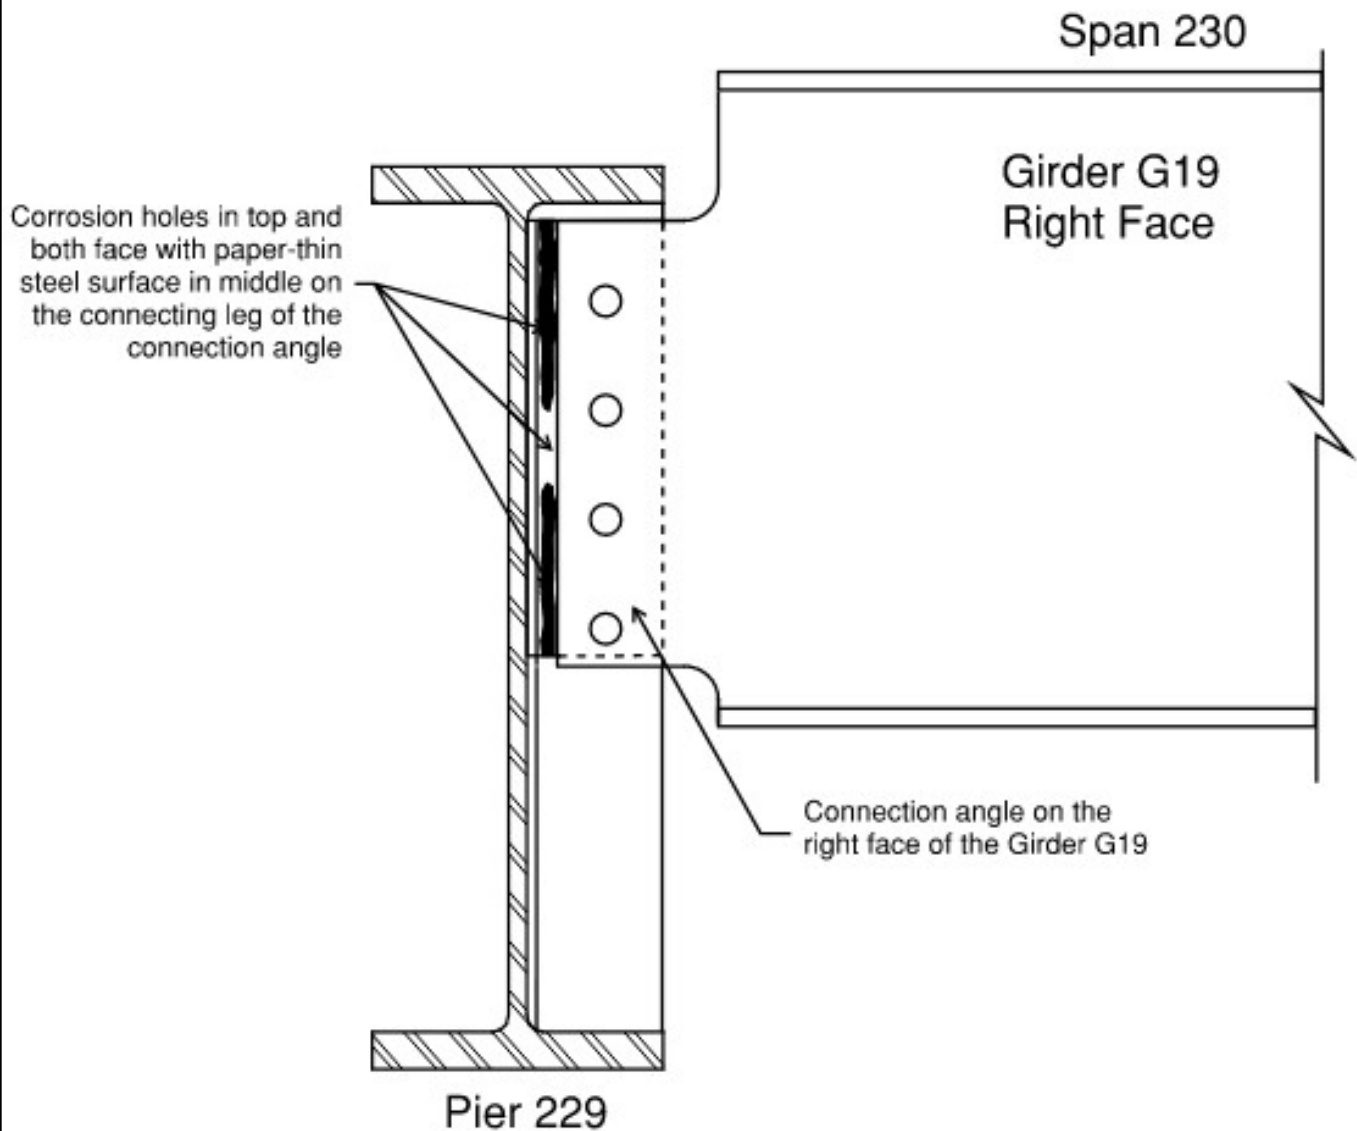
Photo Number: 3

1. The connection angle exhibits large corrosion holes in the top and bottom side of the connecting leg. The portion between these two holes exhibits paper-thin steel surface (See Sketch Photo No.3 and Photo No. 5).

SKETCH FOR PIA RED FLAG # NB23U4W017
SPAN 230, GIRDER G19 AT PIER 229
(LOOKING LEFT)
N.T.S

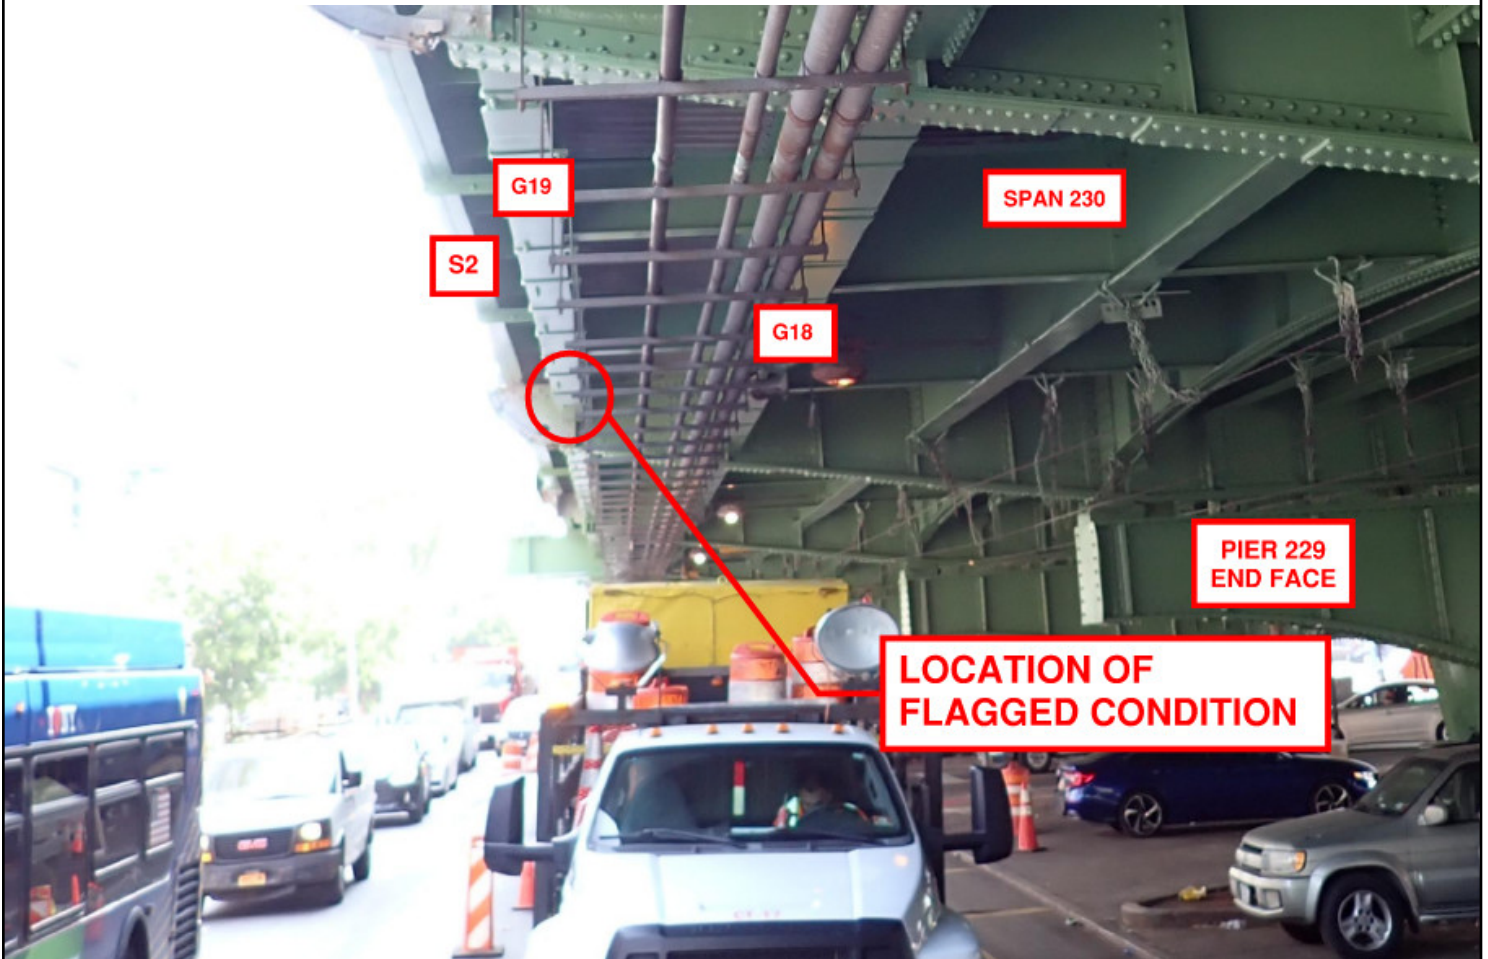
Photo Number: 4

Attachment Description: General View of Flag Location. Looking Begin - Up.

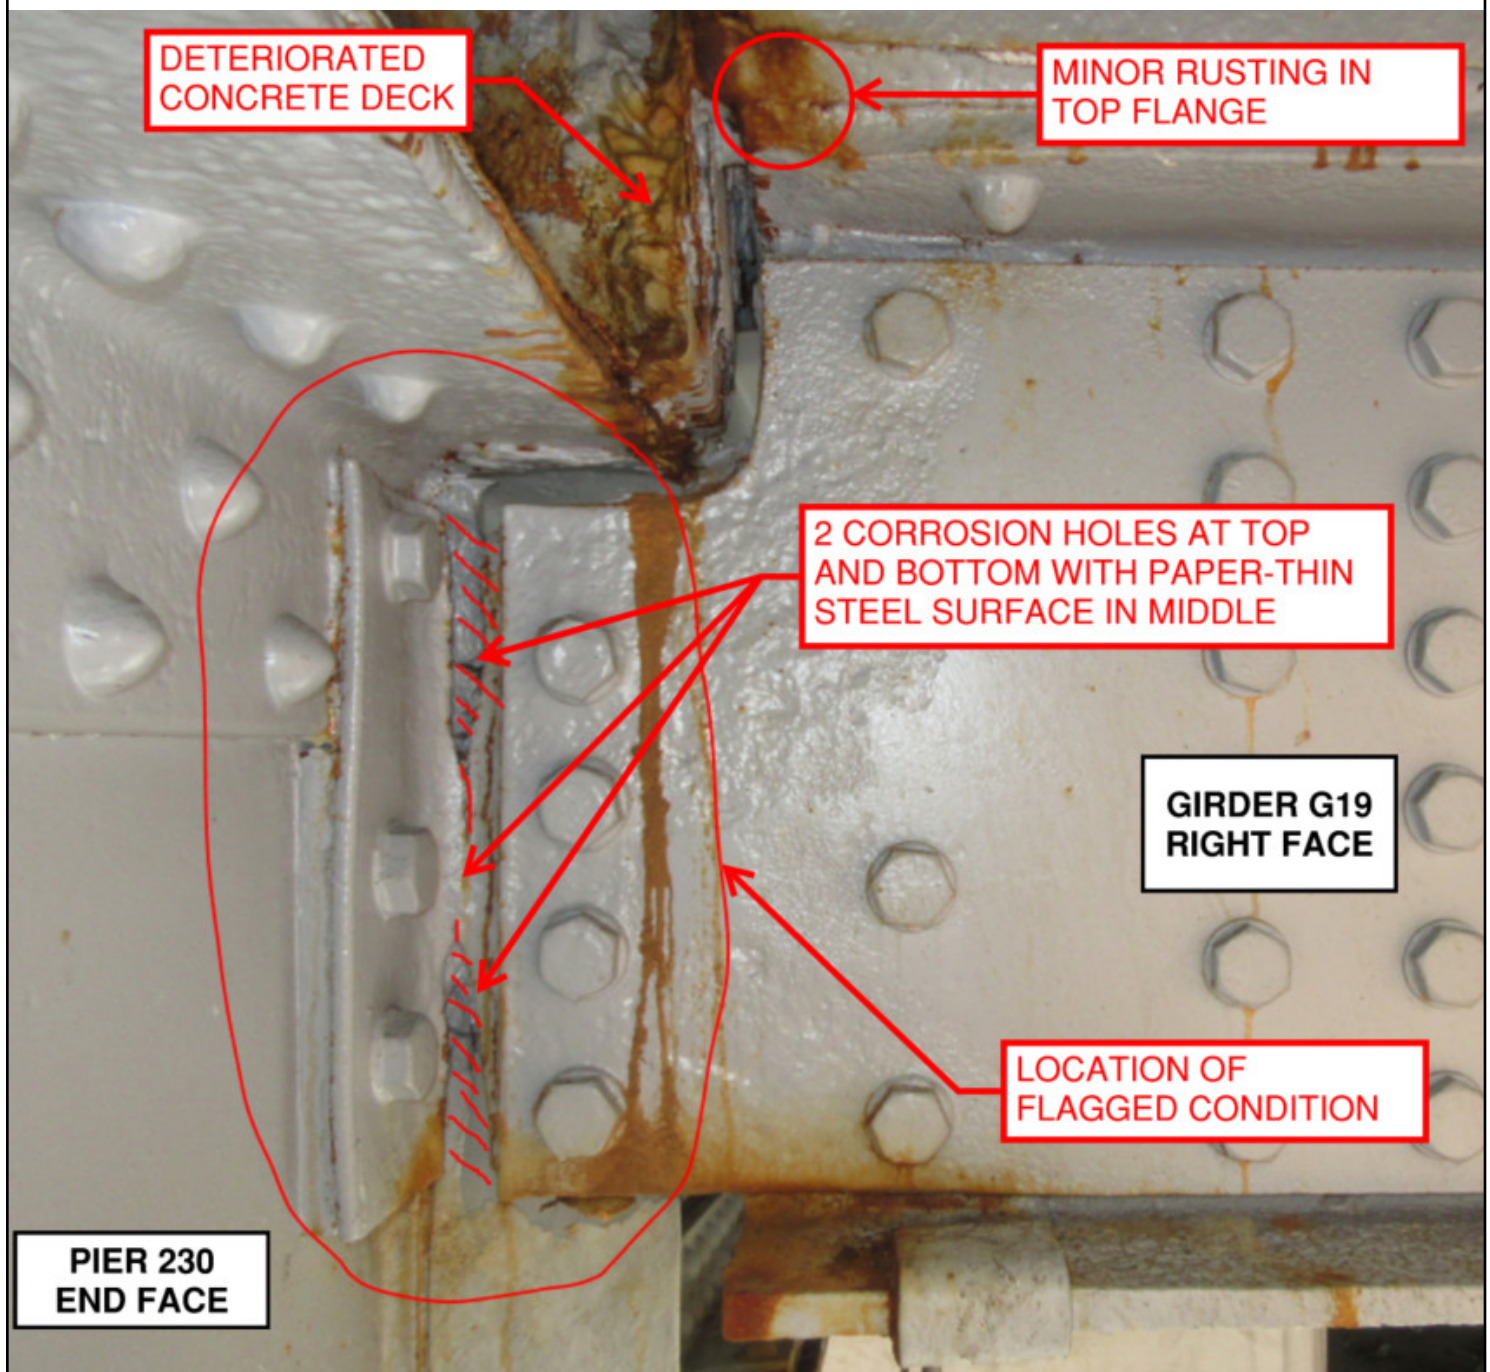
Photo Number: 5

Attachment Description: Connection angle exhibits large corrosion holes in the top and bottom side of the connecting leg with paper-thin steel surface in middle. Looking Left.

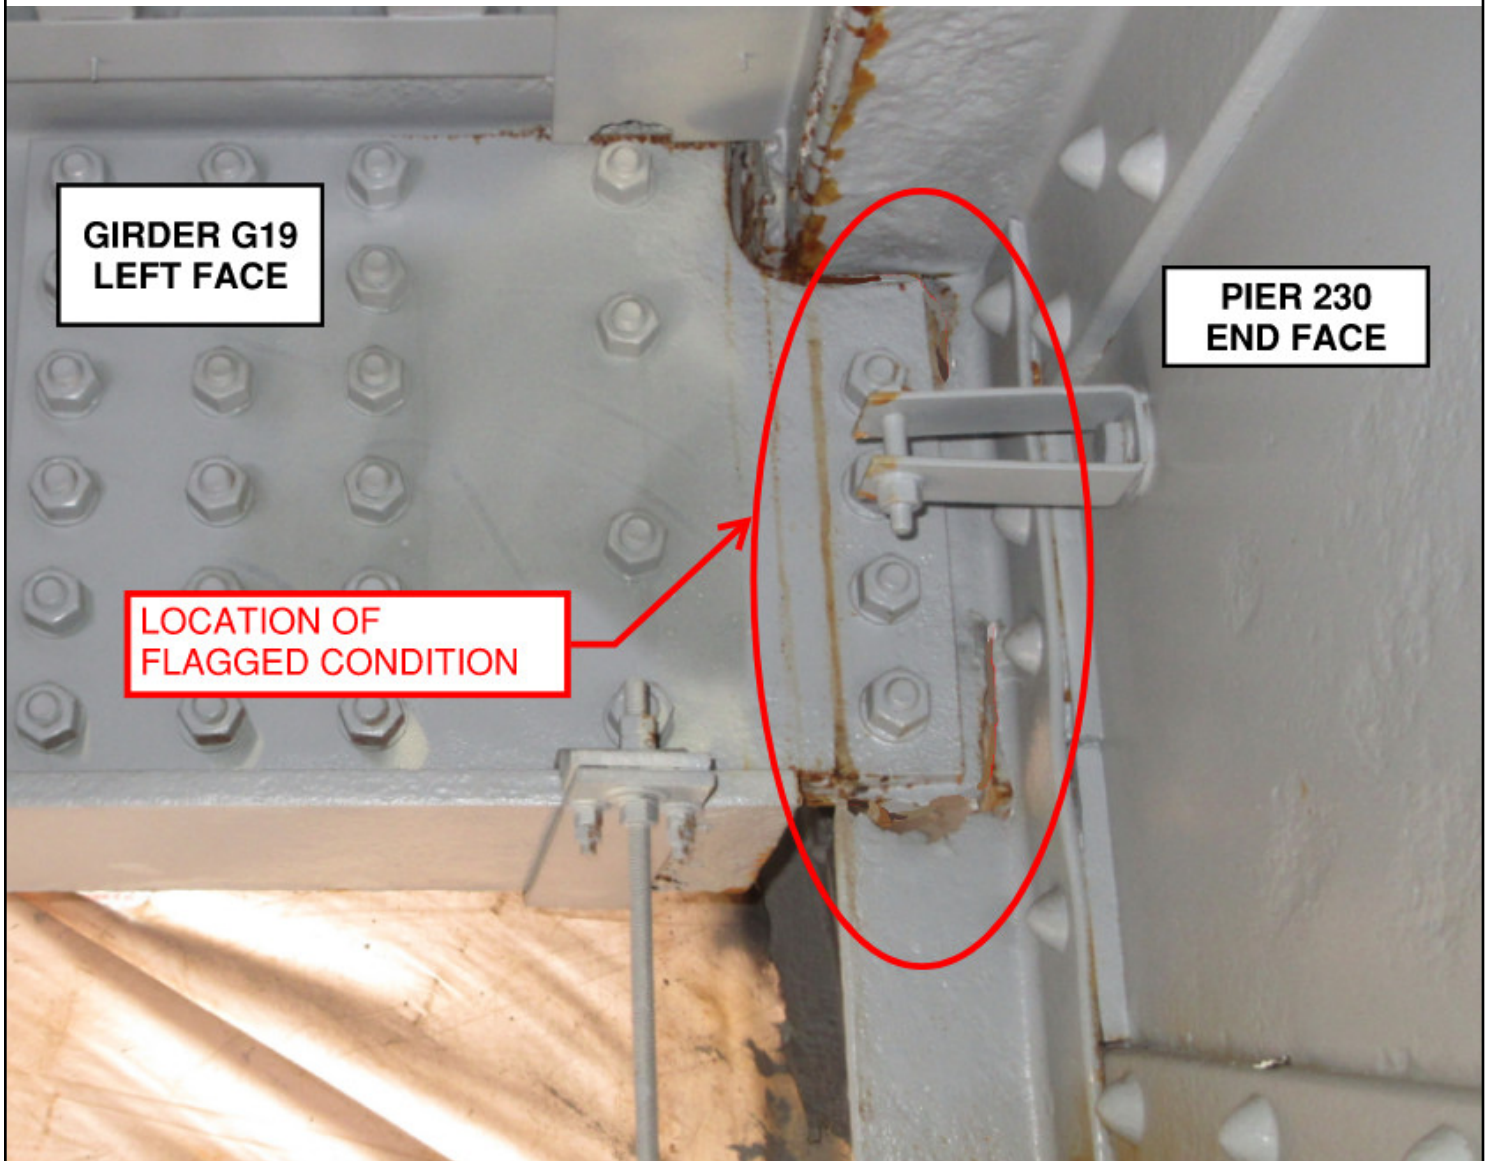
Photo Number: 7

Attachment Description: General View of Girder G19 left face. Looking Begin - Right.

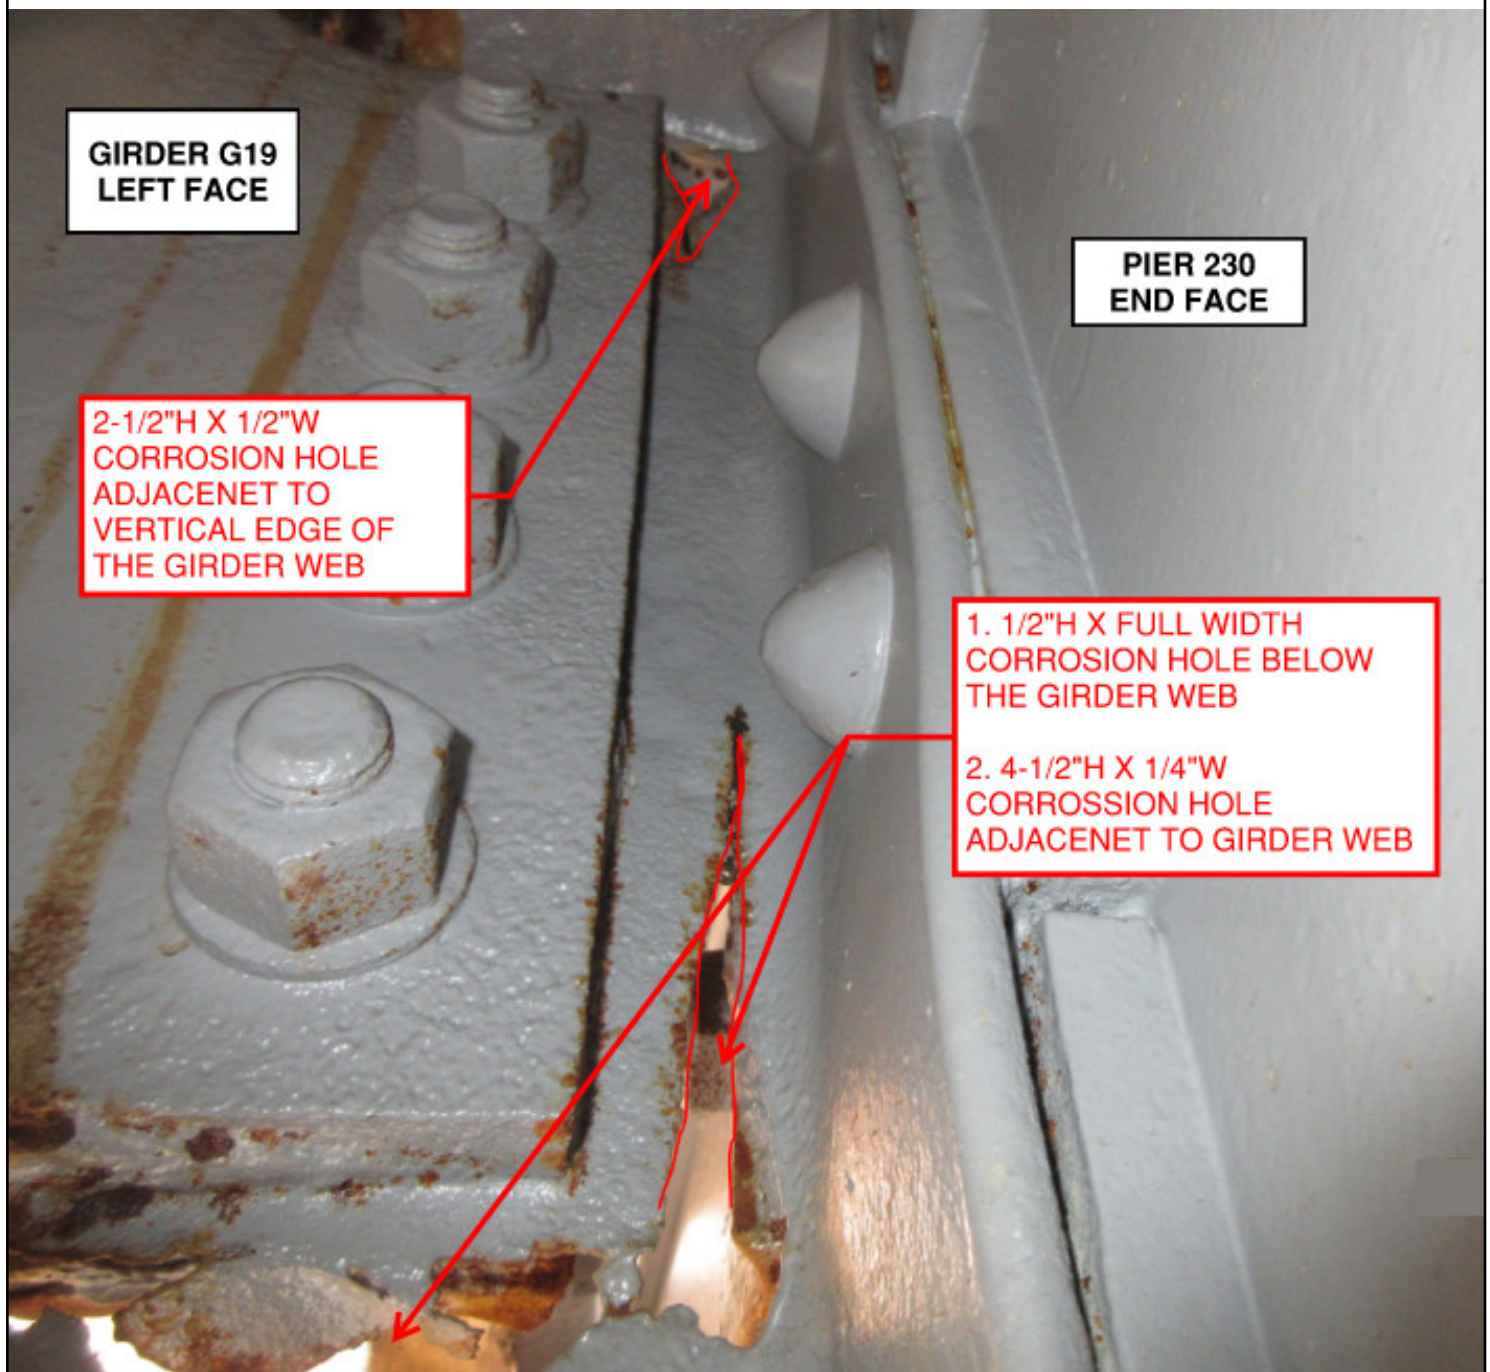
Photo Number: 8

Attachment Description: Connecting leg of the stiffener angle has a 1/2"H x full width hole in top and bottom, and a 2-1/2"H x 1/2"W hole adjacent to the top corner and a 4-1/2"H x 1/2"W hole adjacent to the bottom corner of the girder web end. Looking Right-Up.
